**Demonstration and Evaluation of Technologies for
Determining the Suitability of USTs
for Upgrading with Cathodic Protection**

**Jarius D. Flora, Jr.
Midwest Research Institute
Kansas City, Missouri 64110**

**National Risk Management Research Laboratory
Office of Research and Development
U.S. Environmental Protection Agency
Cincinnati, Ohio 45268**

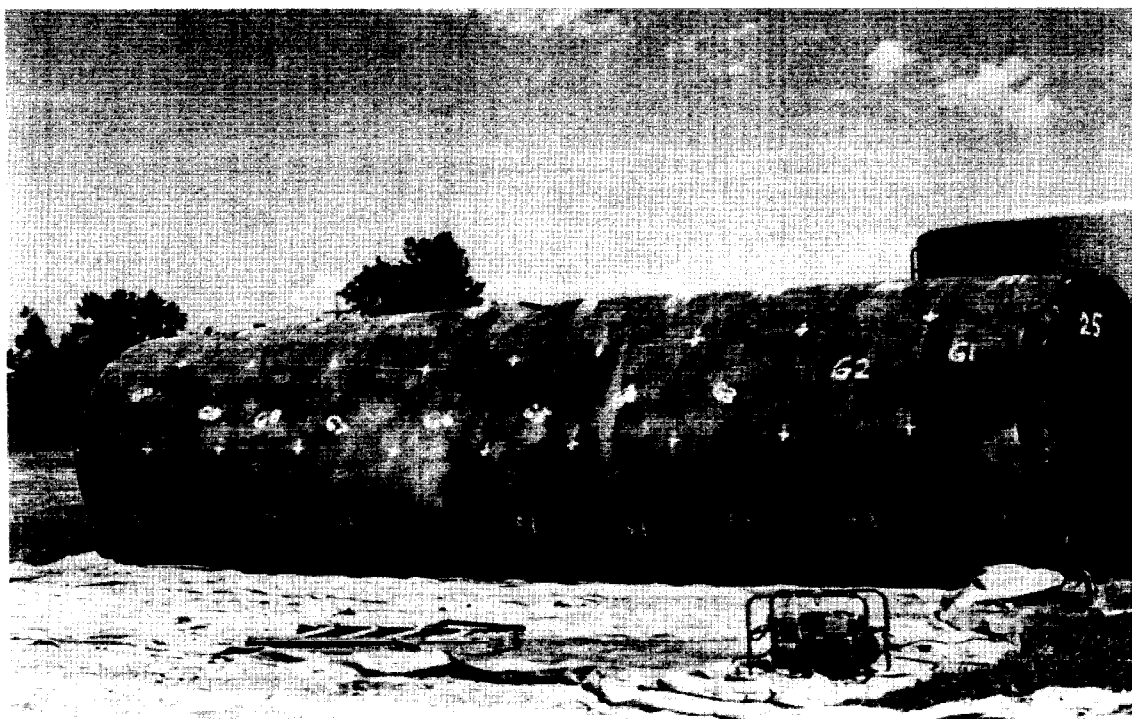
Figure 7 Tank 25 with External Grid and Damage from Removal

Tank No. 25 was the first and most difficult tank to remove, due to the constricted working space and suction caused by wet clay. During removal a track hoe dented the tank along the west side and a hole was punched in the south end of the tank for lifting (Figure 7).

The post-removal visual inspection identified considerable overlapping pitting around the area of the access way. The tank was abrasive blasted and a grid was applied to the tank exterior. After the external inspection was completed, a grid was applied to the tank interior. Data from the external inspection are in Appendix C. The data from the external inspection, internal inspection, and ultrasonic wall thickness measurements are presented

in Appendix C. All welds were found to be Type 1 continuous welds on both ends of the tank. The head joint welds were all of Type 18, continuous full fillet welds on the outside of the tank.

The external inspection identified a number of corrosion pits that were 0.10 inch deep or greater. The depth measurements for the six deepest external pits are presented in Table 2. The values reported are the average of triplicate measurements. The location of each pit is indicated by the reference grid. The location is specified by the grid letter around the tank and the location along the length, as well as the sub-grid within the grid. For example, B 1, 4-5 is in section B, closest to the open end, on the boundary between sub-grids 4 and 5. There were two pits at section C7-3 that were difficult to measure, as they were along a weld seam, one on each side. Both are reported in Table 2. All of these pits exceeded 50 percent of the nominal wall thickness of 0.250 inch. No perforations were found.
